SLICK DUCT SERVICES[®]

Case Study

RZ -ECOSEAL

"A study into the problems Eureka Popcorn Factory faced with their Extraction System and why they opted for RZ-Ecoseal as their long term ducting solution"

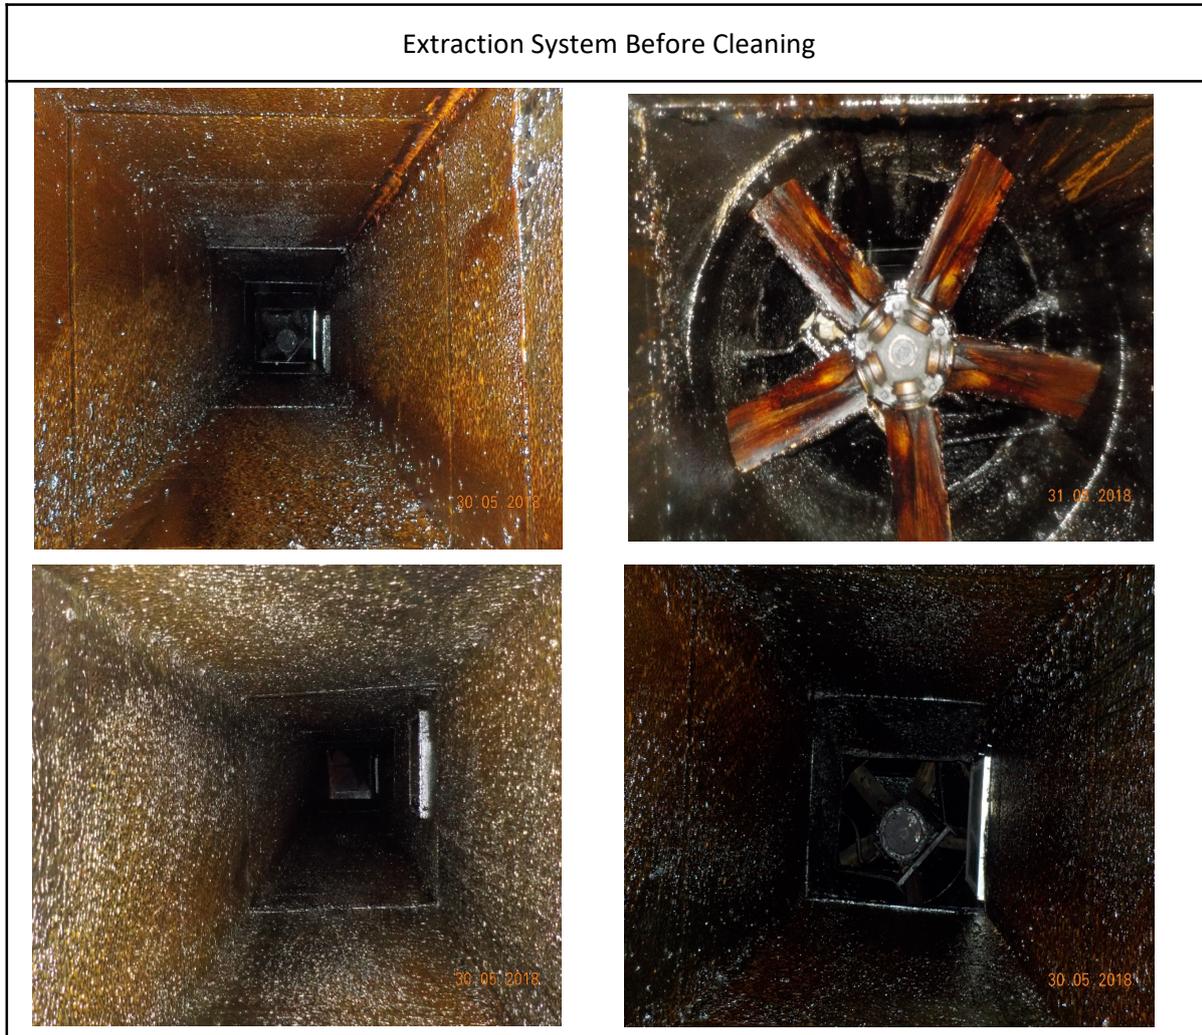
<p>System Grease Accumulation</p>	<p>Extremely High. Layers of oil above critical depth (3175 microns // 0.125mm) hence system is in dire need of maintenance to avoid further system compromise.</p>
<p>System Condition</p>	<p>System is an immediate fire risk due to high amounts of grease throughout ducting. High amounts of puddles and carbonized oil found along ducting system.</p>
<p>Production Conditions</p>	<p>Production area is extremely hot and floors covered in grease (hot air and grease not being removed efficiently due to condition of system) . Constant leaks from system onto ceiling boards and floors.</p>

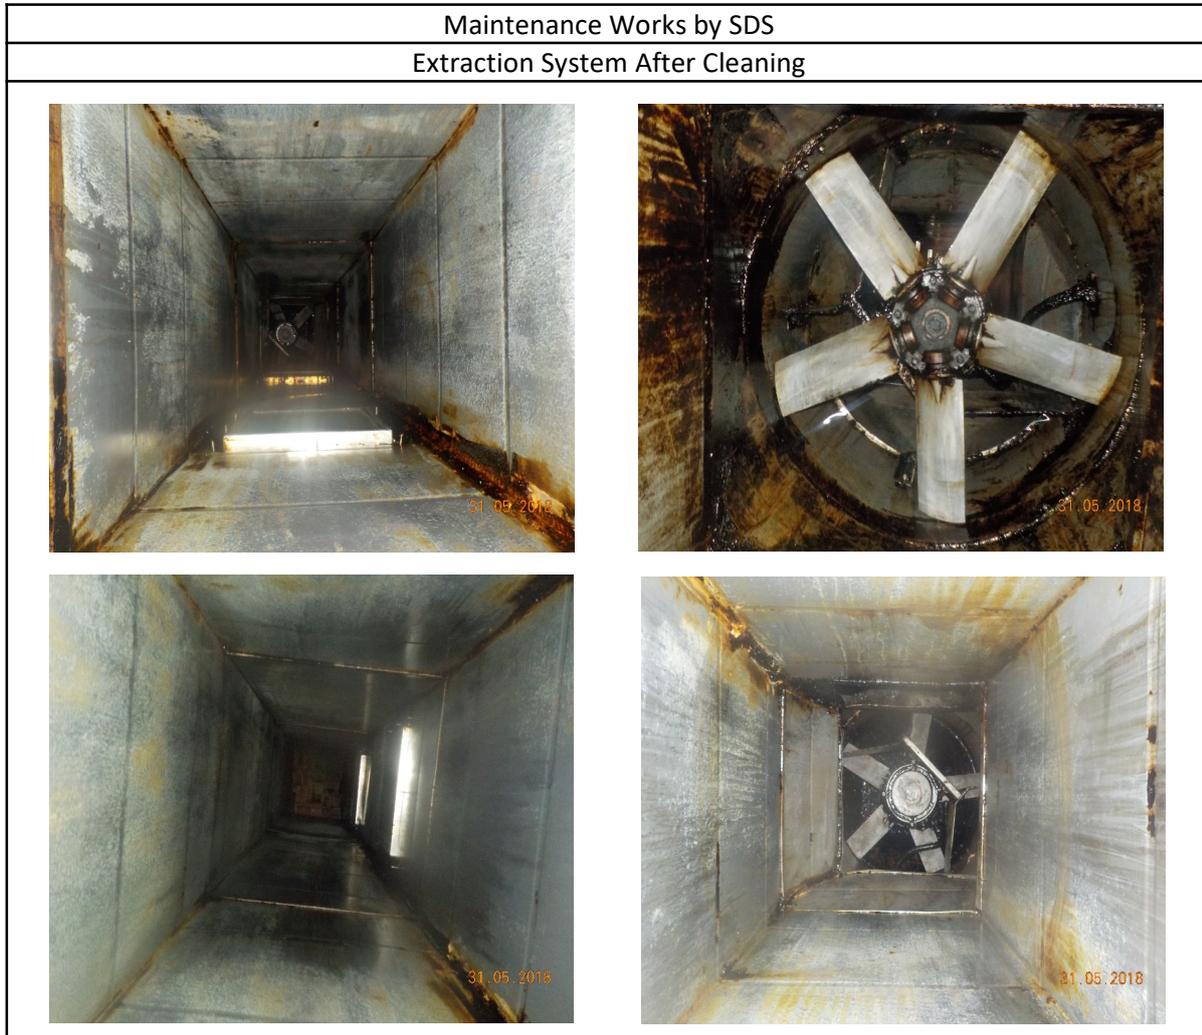
System Condition after Maintenance	Low. Layers of oil below 50 Microns (0.002mm) and is no longer a fire risk
Findings after Maintenance	System maintenance took 2 days to complete with 4 manpower Difficulty of maintenance work High System will still leak if maintenance not done every 3-4 months
Production Conditions	Quality of air in production area has improved and is not as hot and stuffy as before. Drip Pans installed to avoid leaking onto ceiling boards.
Initial System Maintenance Recommendations	System is to be cleaned every 4 months or mayr risk being compromised due to high accumulations of grease and type of food production done.

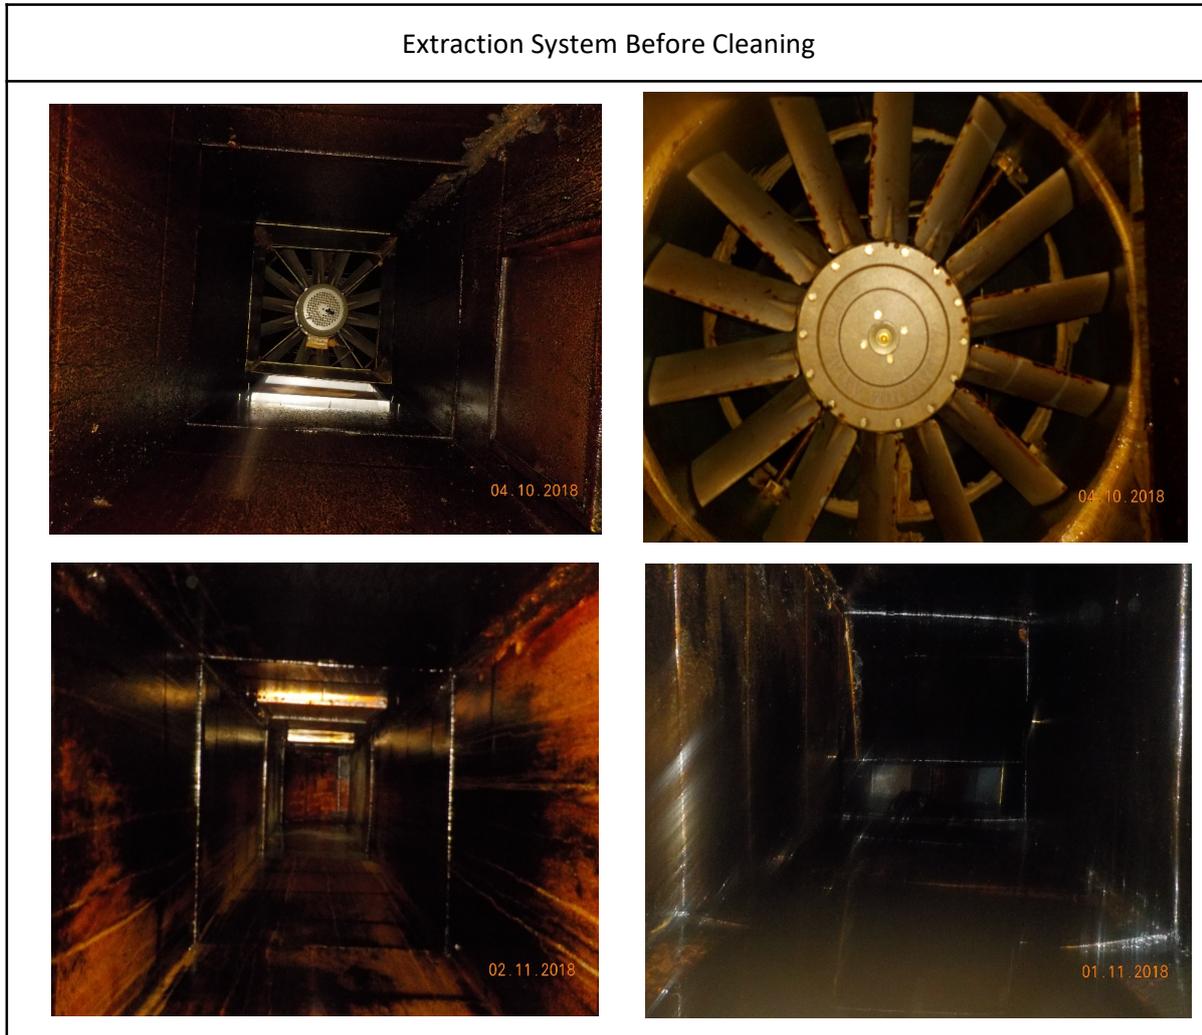
<p>System Grease Accumulation</p>	<p>Extremely High. Layers of oil above critical depth (3175 microns // 0.125mm) hence system is in dire need of maintenance to avoid further system compromise even though system was fully cleaned during last maintenance</p>
<p>System Condition</p>	<p>System is an immediate fire risk due to high amounts of grease throughout ducting. Puddles and carbonized oil found along ducting system.</p>
<p>Production Conditions</p>	<p>Production area gets hotter as time goes by (hot air and grease not being removed efficiently due to condition of system) . Leaks from system into drip pans and floors.</p>

Due to the type of cooking and production rates Slick Duct Services recommends changing cleaning frequency to every 4 months (3 X Per Yer)

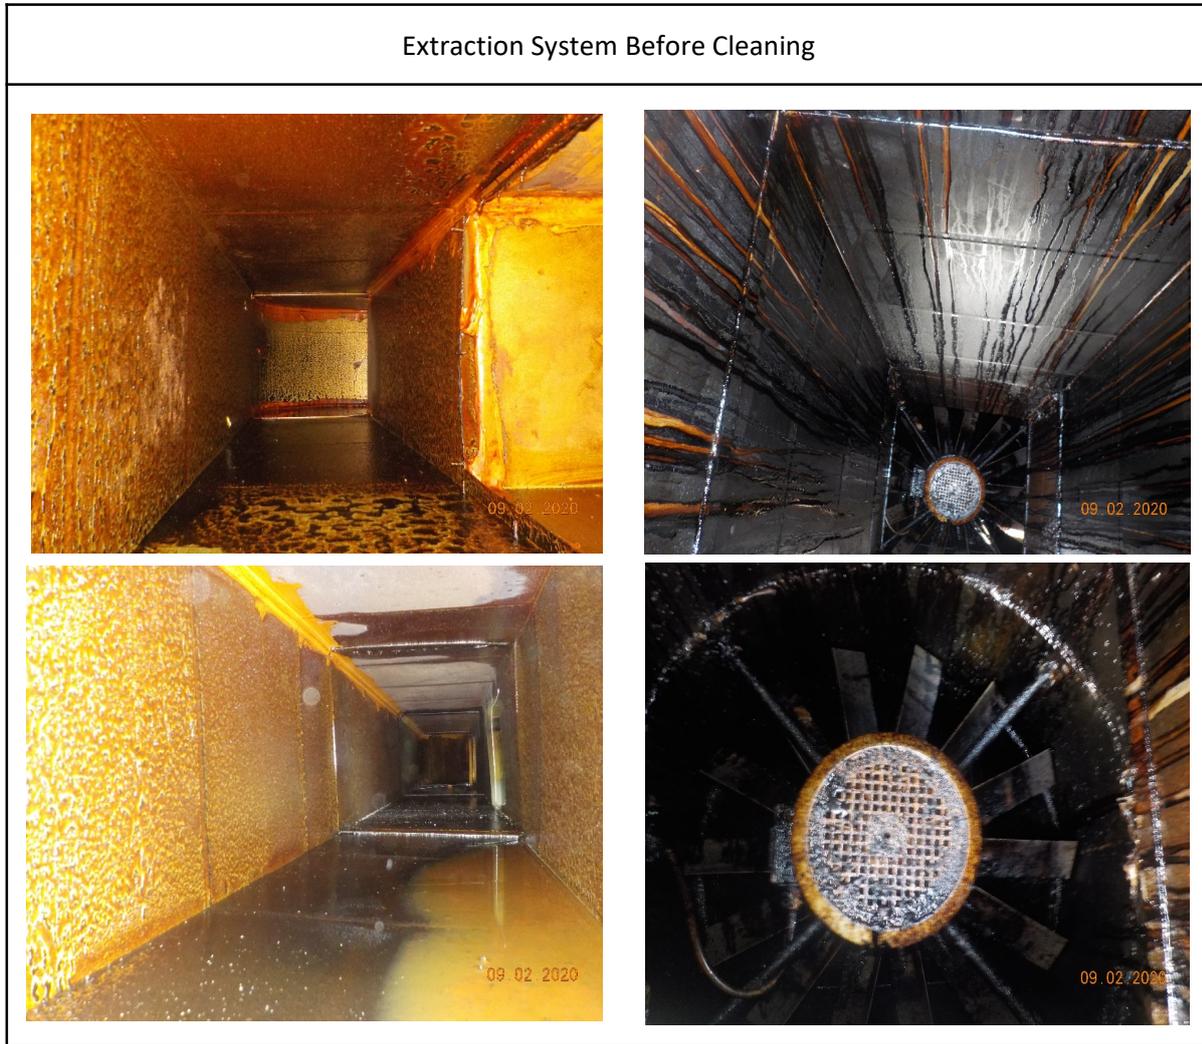
<p>System Grease Accumulation</p>	<p>High. Layers of oil above critical depth (3175 microns // 0.125mm) hence system is in dire need of maintenance to avoid further system compromise even though system was fully cleaned during last maintenance .</p>
<p>System Condition</p>	<p>System is an immediate fire risk due to high amounts of grease throughout ducting. Puddles found along system however less carbonized oil within system .</p>
<p>Production Conditions</p>	<p>Production still hot(hot air and grease not being removed efficiently due to condition of system) . Leaks still persistant from system into drip pans and floors.</p>

Due to the type of cooking and production rates to avoid large cleaning cost at short intervals Slick Duct Services recommends the application of RZ Ecoseal throughout the entire Extraction System.

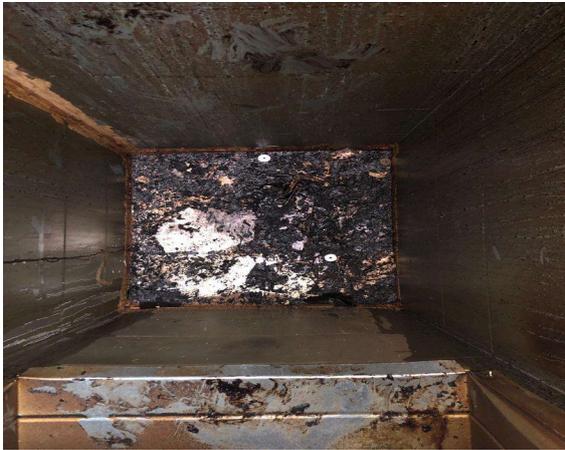
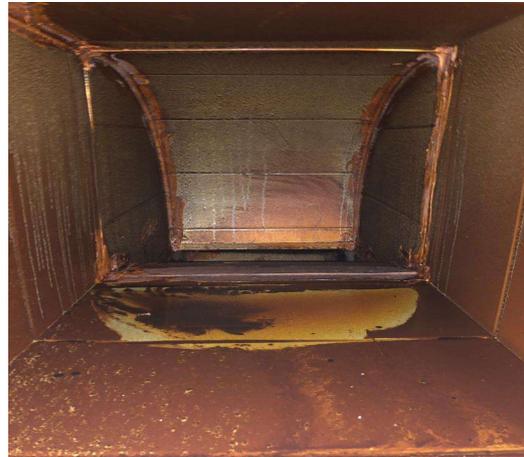
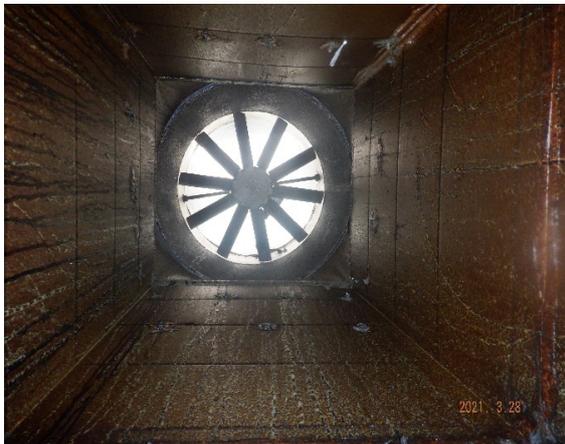
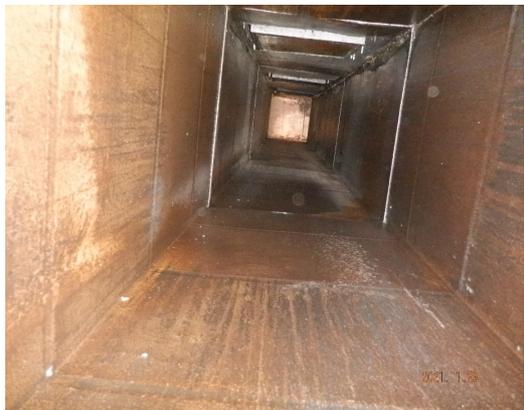
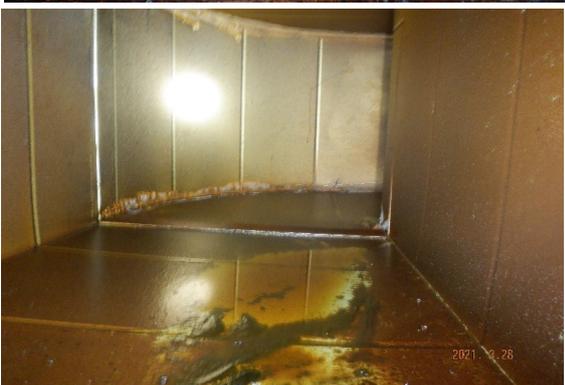
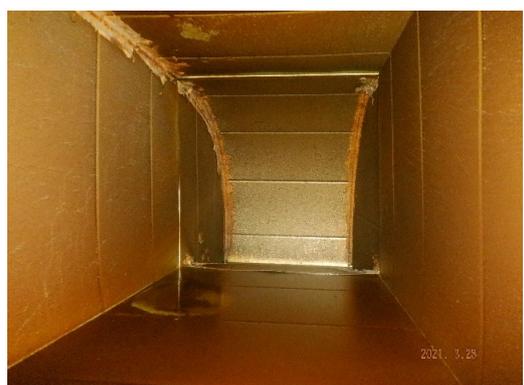
Extraction System Before Cleaning

System Grease Accumulation	High. Layers of oil above critical depth (3175 microns // 0.125mm) hence system is in dire need of maintenance to avoid further system compromise.
System Condition Before Rz-Ecoseal	System is an immediate fire risk due to amounts of grease throughout ducting. Puddles also found along ducting system.
Production Conditions	Production area gets hotter as time goes by(hot air and grease not being removed efficiently due to condition of system) . Leaks from system into drip pans and floors.

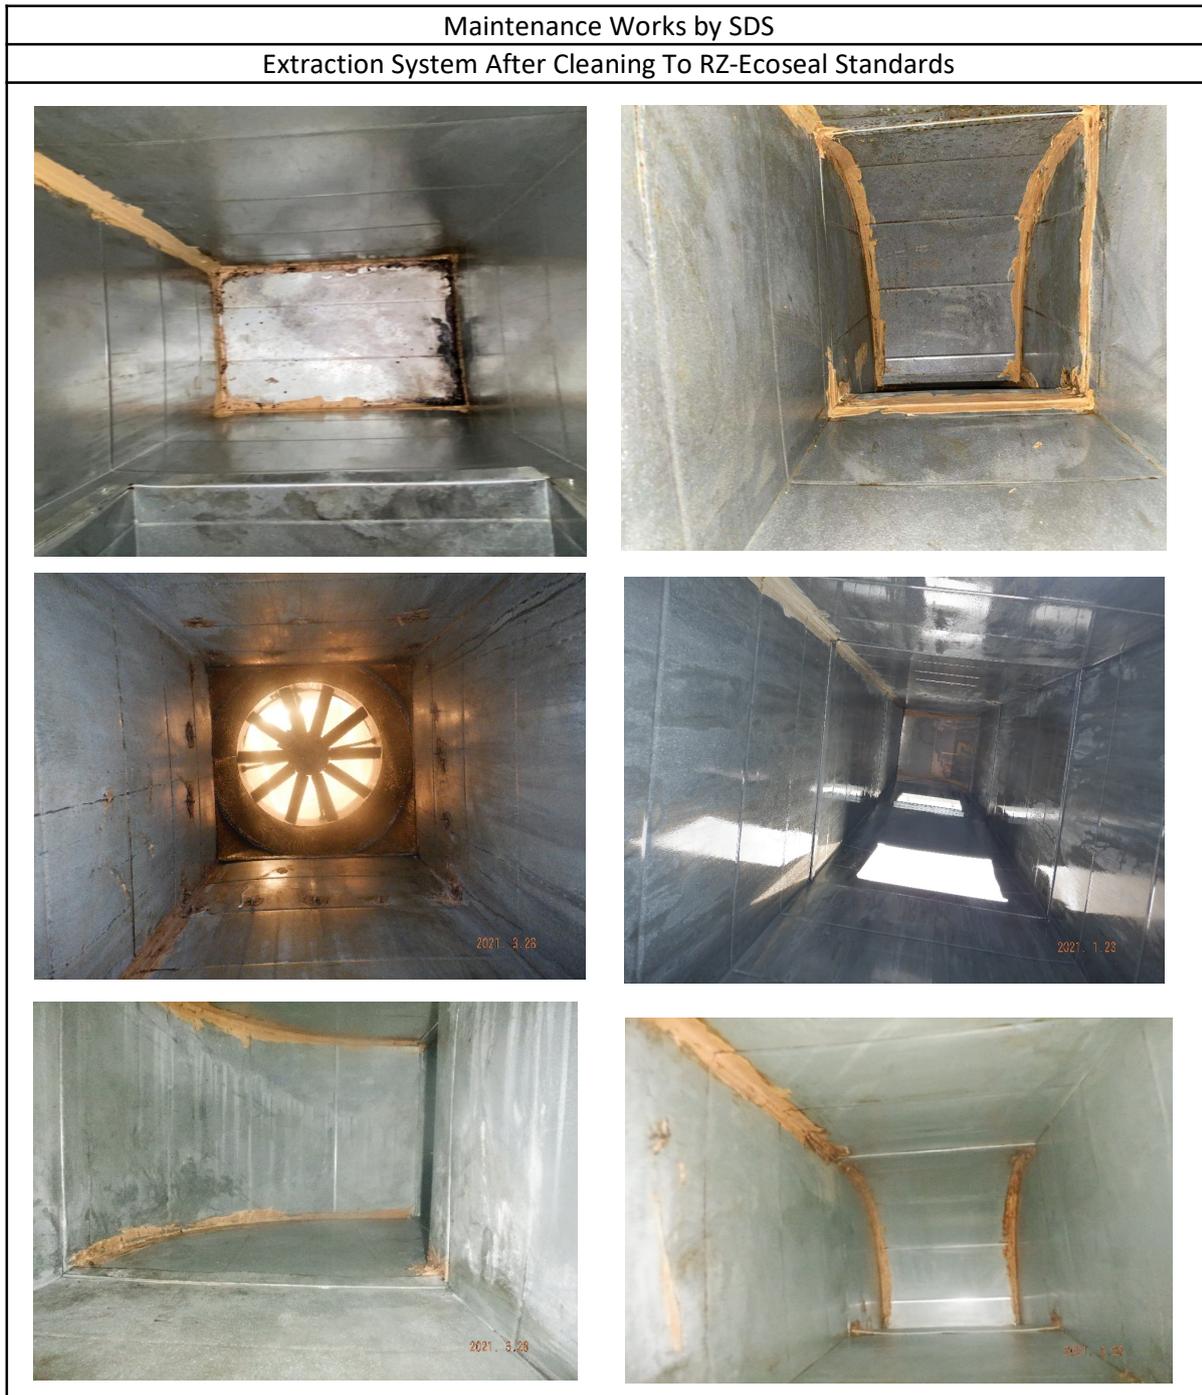
System Condition after Maintenance	Zero grease left . Layers of oil below 50 Microns (0.002mm) and is no longer a fire risk.
Ducting Condition before Application of Rz-Ecoseal	System preparation took 2 days to complete with 4 manpower
	Difficulty of maintenance work HIGH
	System is ready for application of RZ-Ecoseal.

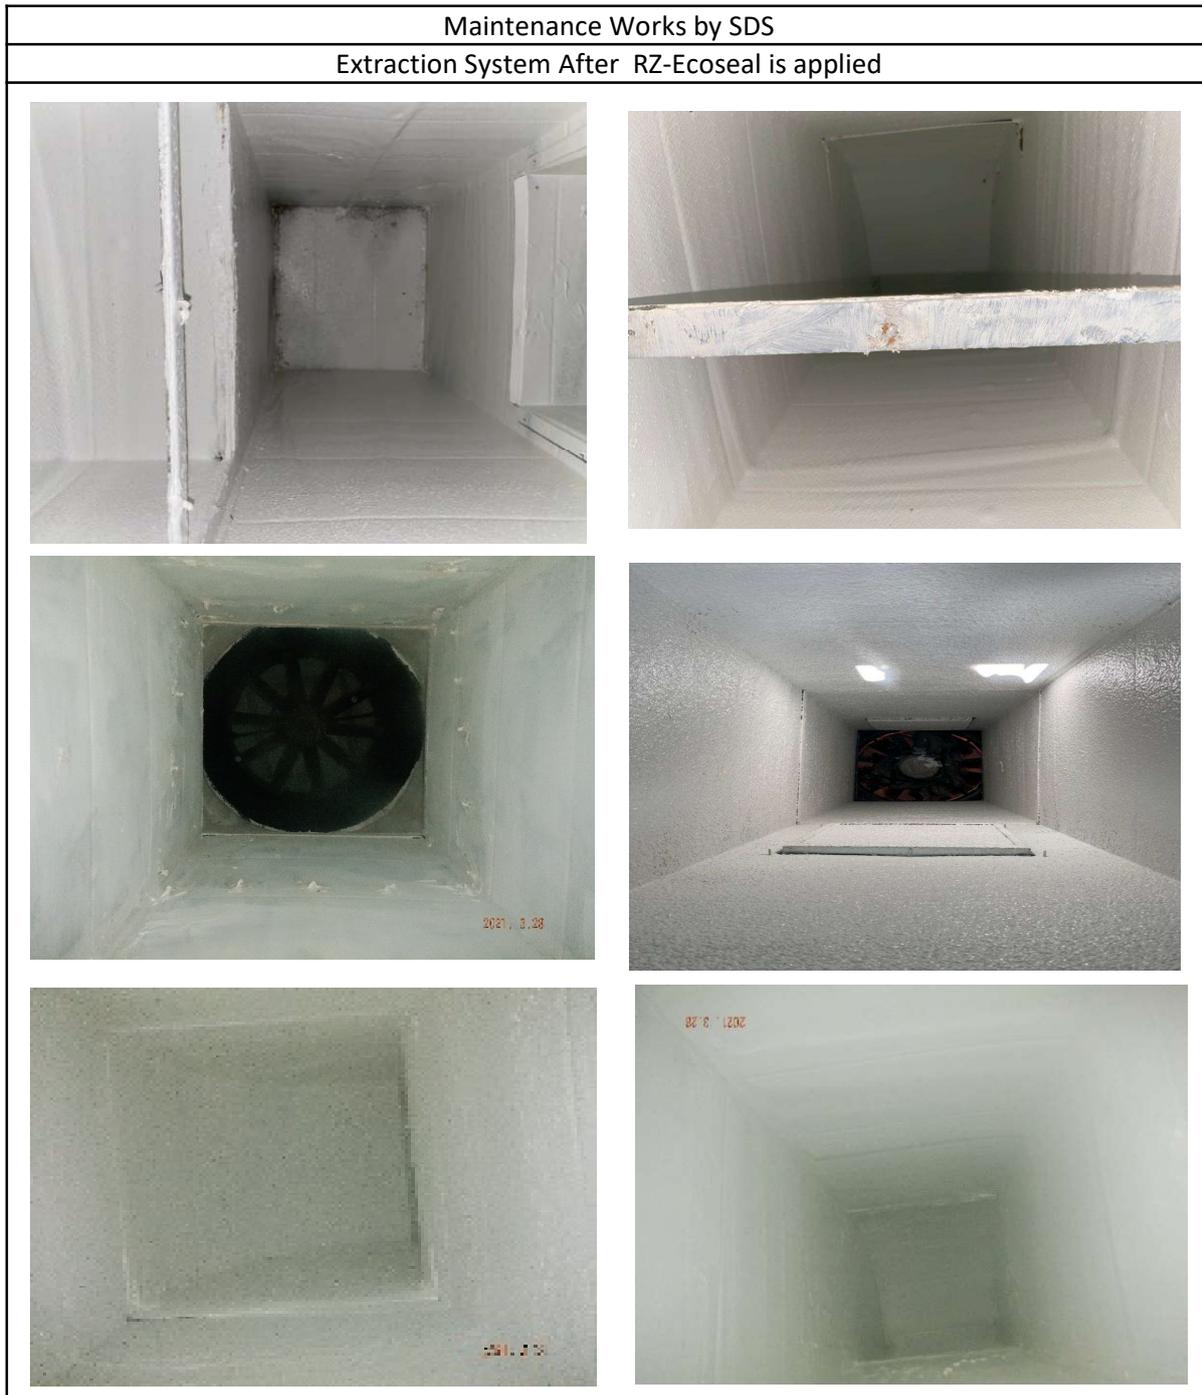
System Condition after Maintenance	Zero grease left . Layers of oil below 50 Microns (0.002mm) and is no longer a fire risk. System is also fully encapsulated and protected.	
Ducting Condition after Application of Rz-Ecoseal	Rz-Ecoseal applied to entire ducting system excluding fan	
	Difficulty of maintence work after application	Low
	System is to be maintained by authorized personal to avoid any damage to Rz-Ecoseal

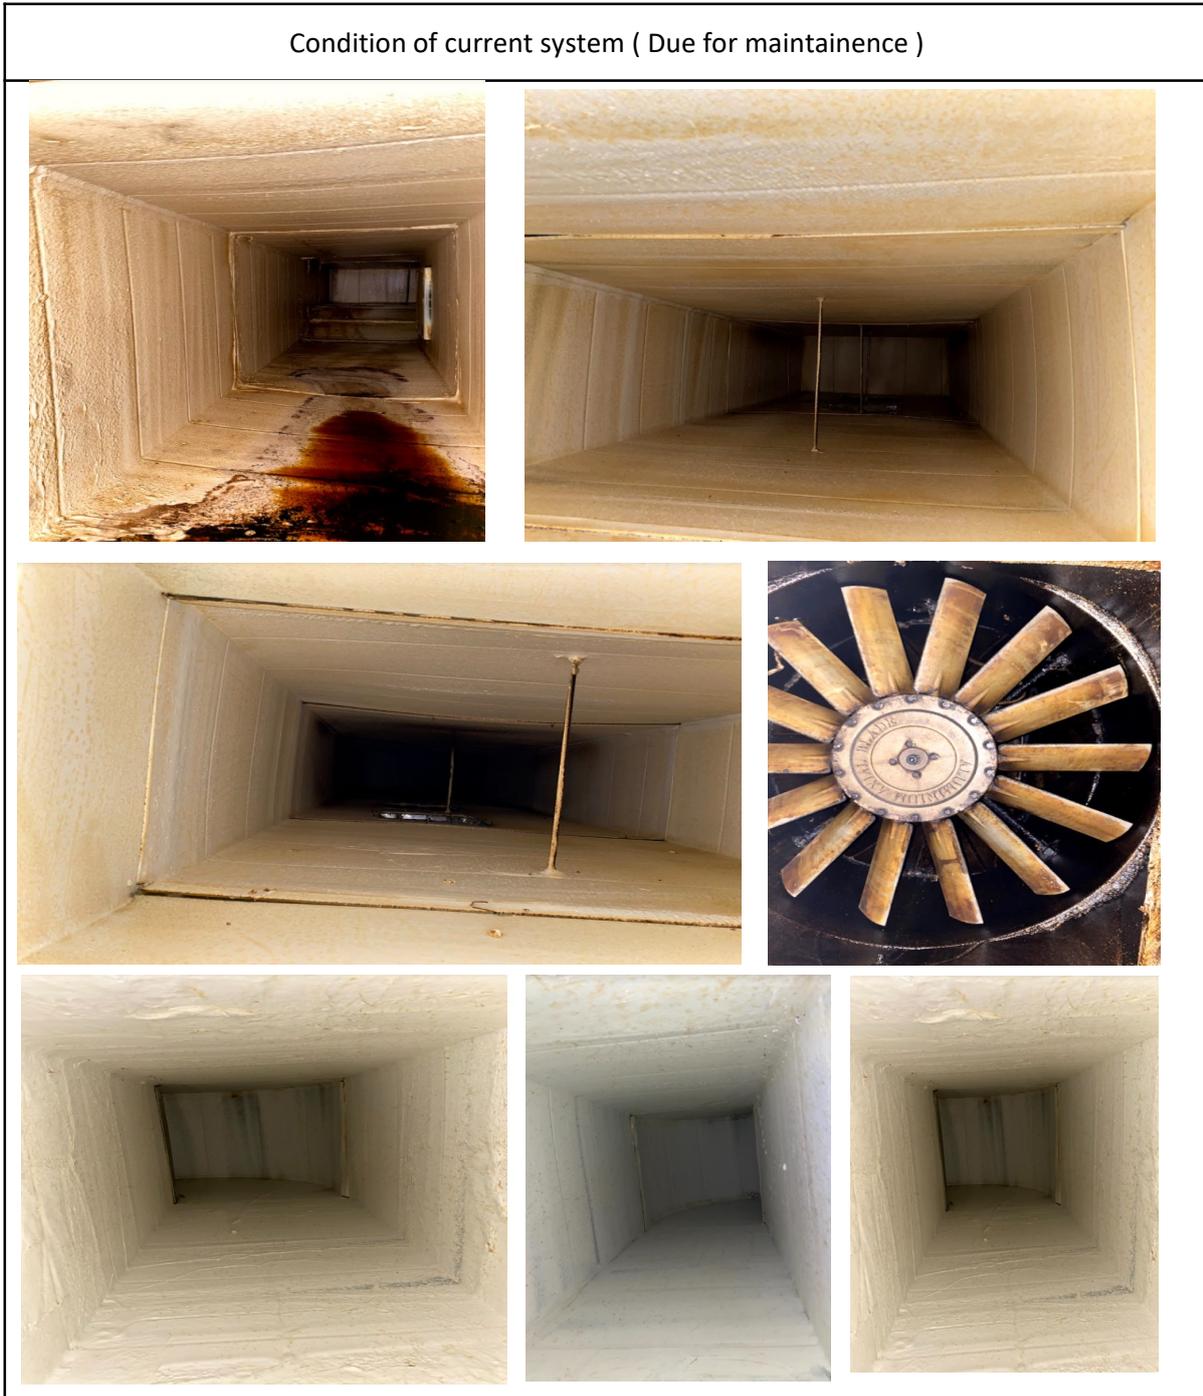
System Condition	Minimal grease found thourhgout system . Layers of oil at 2000 Microns (0.075mm) and is no longer a fire risk however, is due for servicing.	
Ducting Condition after Application of Rz-Ecoseal	No more leaks found	
	Difficulty of maintenance work (4 man 1 Day)	LOW
	System is fully encapsulated and Rz-Ecoseal has adhered well to ducting
