SLICK DUCT SERVICES[®]

Case Study

RZ -ECOSEAL

"A study into the problems Eureka Popcorn Factory faced with their Extraction System and why they opted for RZ-Ecoseal as their long term ducting solution"

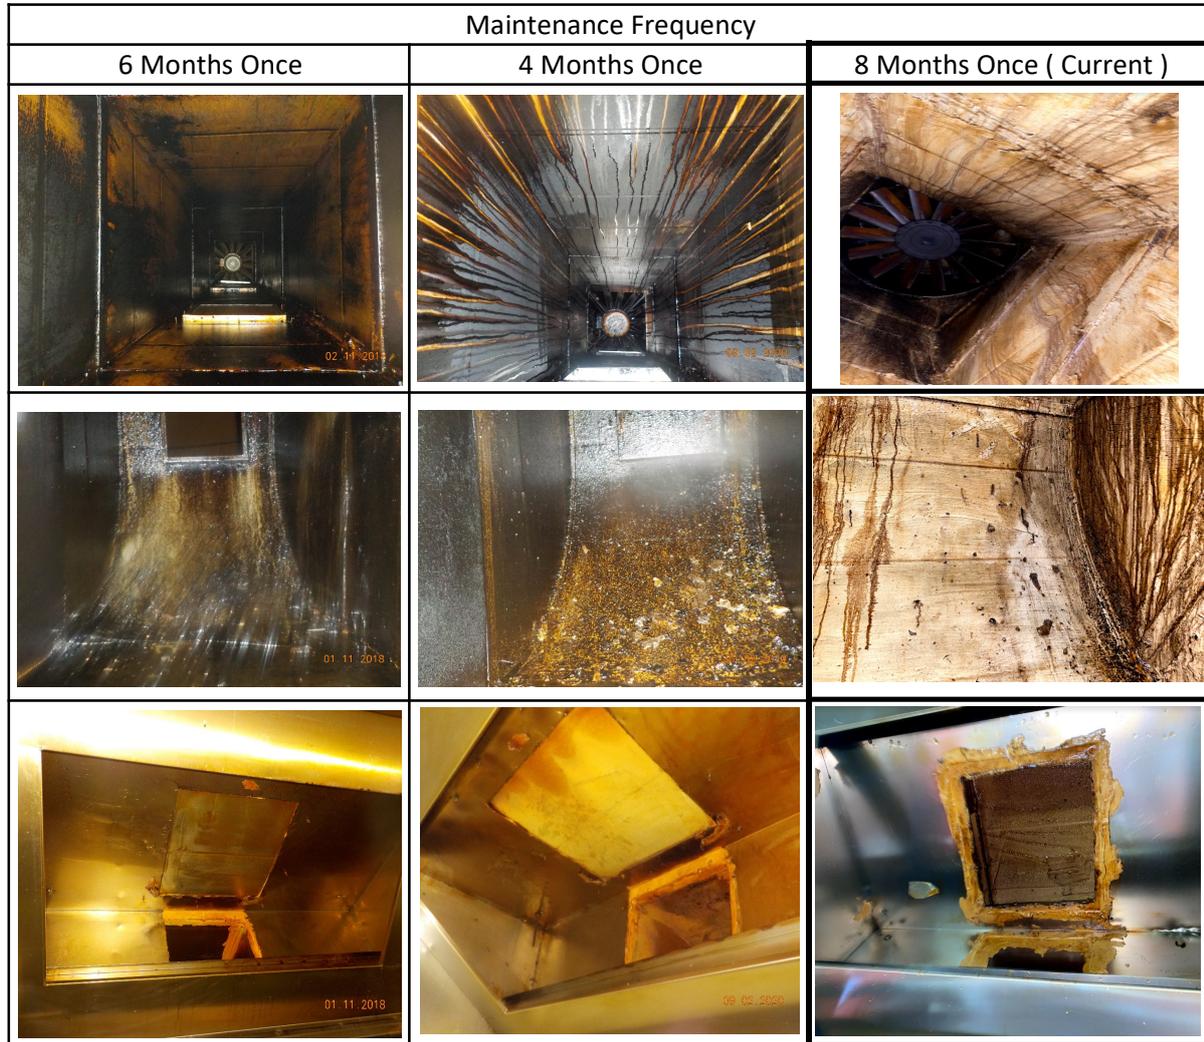
Comparitive Analysis of Extraction System

No RZ-Ecoseal	No RZ-Ecoseal	Rz-Ecoseal Applied
System Grease Accumulation		
Extremely High. Layers of oil above critical depth (3175 microns // 0.125mm)	High. Layers of oil above critical depth (3175 microns // 0.125mm)	Med. Layers of oil above at acceptable micron depth before maintenance (2000 microns // 0.075mm)
System Condition		
Immediate Fire Risk	Fire Risk	Not at Risk
Production Conditions		
Bad	Bad	Good

Current system maintenance recommendation is most optimal.
